Occlusal Diagnosis and Treatment for A Patient with Unconscious Mouth Opening Disability: A Case Report

ABSTRACT

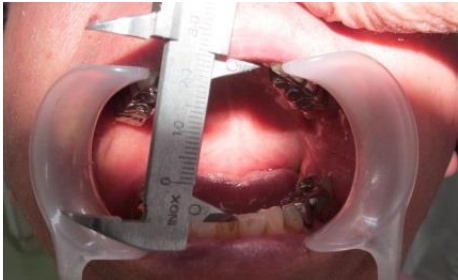
Figure 1: Opening disability at first visit

A 69-year-old man presented with complaint of detachment of filling from lower left first molar. However, because it was difficult to open the mouth, the opening was measured and it was only 37 mm (Fig. 1). The patient was unaware of the opening disability. The patient's medical history was unremarkable. No deviation of the opening path, and no noise of the temporomandibular joints (TMJs) was detected.

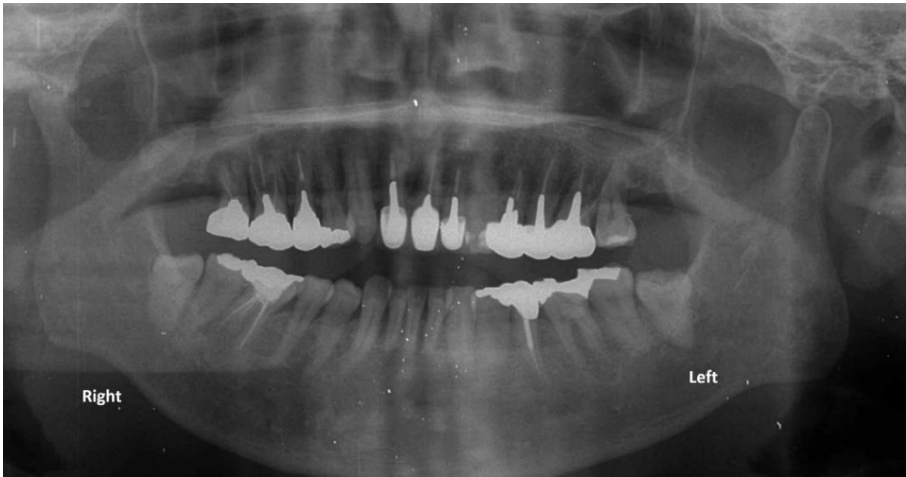
Figure 3: X-ray images of upper and lower dental arches

However, the patient reported pain in the right TMJ when moving the jaw. He didn't report any tenderness on palpation of both TMJs. He reported tenderness of the right lateral and medial pterygoid muscles on palpation. Twenty-six teeth existed. Both lower third molars were semi-impacted (Fig. 2 and 3). Occlusion was anatomically normal. The TMJs appeared normal on the TMJ computed tomography (CT) images (Fig. 4). However, the morphology of the right TMJ was unclear compared to the left, but the cause was unknown. With the patient's consent, an occlusal splint was fabricated and fitted to the patient (Fig. 5). The splint was worn by the patient for one week [2]. However, since this therapy had no effect, upper and lower jaw models were made and attached to an articulator using wax records of muscular occlusal position (MOP). The reproducibility of the wax record was confirmed by the split cast method [3]. A habitual occlusal position (HOP) record was obtained by voluntary jaw closing using a

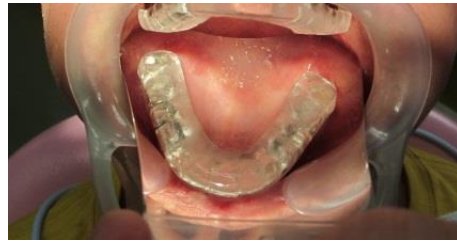
Figure 5: Wearing the occlusal splint

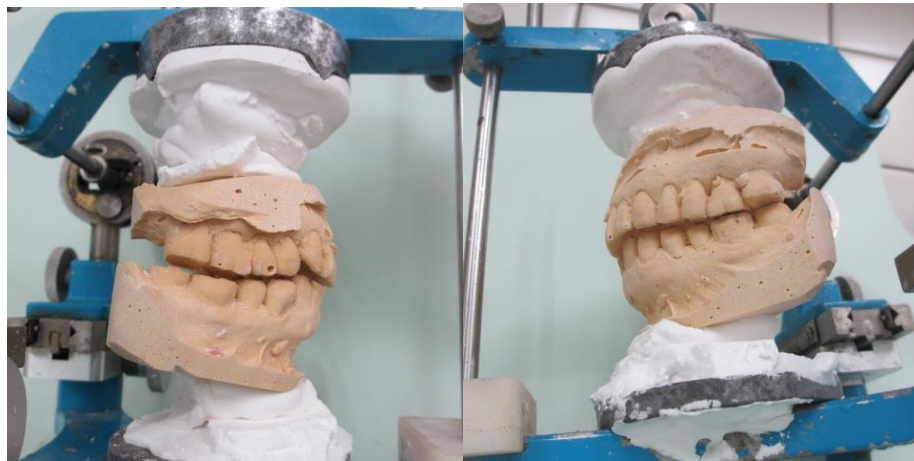
Figure 7: Left premature contact and right occlusal gap

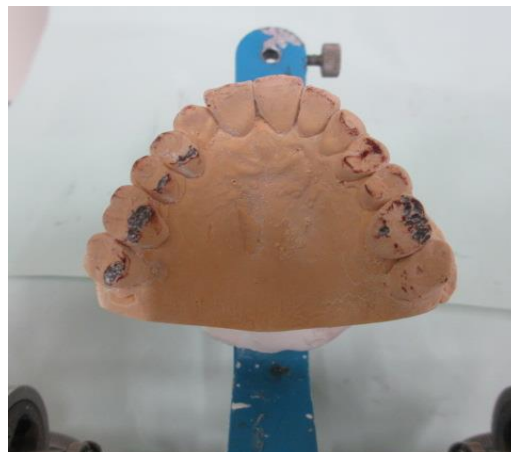
Figure 8: Pencil markings of occlusal adjustment areas

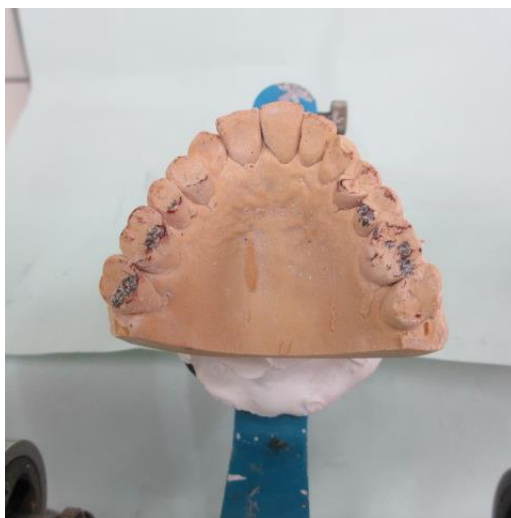
Figure 10: Additional occlusal adjustment marked with pencil

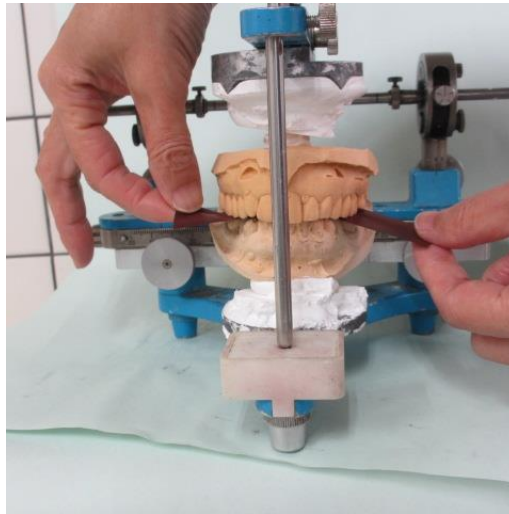
Figure 12: Confirmation of occlusal contacts on both sides in the muscular occlusal position

vinylpolysiloxane bite registration material (GC, Tokyo, Japan). A muscular occlusal position record (MOP) was obtained from the models mounted on the articulator using the same material as in HOP. To examine the difference between HOP and MOP, two-dimensional measurements were performed on a modified articulator using previous records. The differences were not recorded (Fig. 6). As a result of occlusal analysis, premature contact was noted on the left second molars (Fig. 7). After removing the premature contact from the mouth, an impression was taken, the model was attached to an articulator, and the occlusion was adjusted on the model until the molars on both sides were in contact, and the occlusion was also adjusted in the oral cavity in the same way (Fig. 8) [3]. Immediately after this adjustment the opening increased to 43 mm. The patient reported that the stiffness on the right side of his face was gone and he could open his mouth with ease (Fig. 9). Additionally, minor adjustments were made to the occlusion (Fig. 10). After that, TMJ computed tomography images were taken (Fig. 11). The position of the right condyle was unchanged from before the occlusal treatment. Therefore, it was speculated that the opening disability was caused by factors other than the temporomandibular joint. The treatment was completed by checking the occlusion of the left and right molars on the model attached to the articulator (Fig.12).
